**IN-DASH INSTALLATION KIT FOR
SELECT 1992-UP GENERAL MOTORS/HUMMER/
ISUZU VEHICLES WITH OVERSIZE RADIO/M3000**

GM1583 POCKET PREPARATION

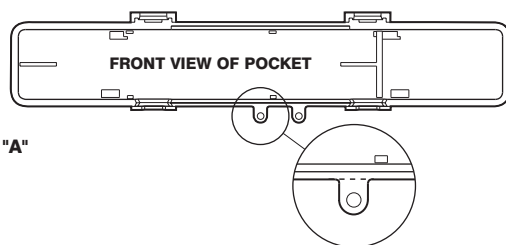
ILLUSTRATION "A"

1. Cut along dotted line to remove middle screw mounting tab. (Illustration "A")

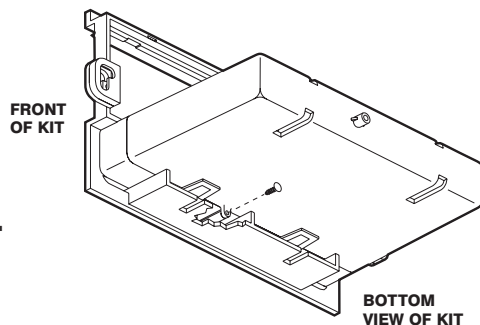
ILLUSTRATION "B"

2. Attach pocket to kit for added pocket strength, attach screw as shown in illustration (Illustration "B")
